Corrosion of Steel Hardware Caused by Pressure-Treated Lumber

8.5 Pressure-treated lumber: a ticking time-bomb since... 2004?

Earthquake Retrofits for Wood-Framed Buildings—a Practical Guide

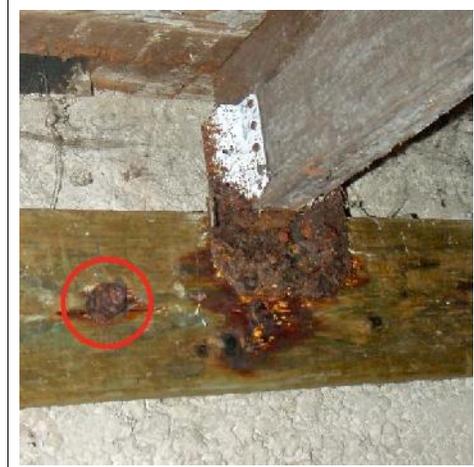
Figure 8-45 Most wood now sold to resist decay also attacks steel connectors. The red circle shows a rusted concrete anchor. At center is an H10 (compare to Figure 6-34). This installation was about 10 years old.
Photo: Matt Cantor, GGASHI

Imagine constructing a house using building materials that will quietly destroy each other. Millions of homes have been built using such materials; the hardware pictured in Figure 8-45 shows severe corrosion of steel connectors in contact with chemically treated lumber. Future failures of structural connections will surprise a lot of building professionals and homeowners; if you have this material in your home you still have time to avert disaster.

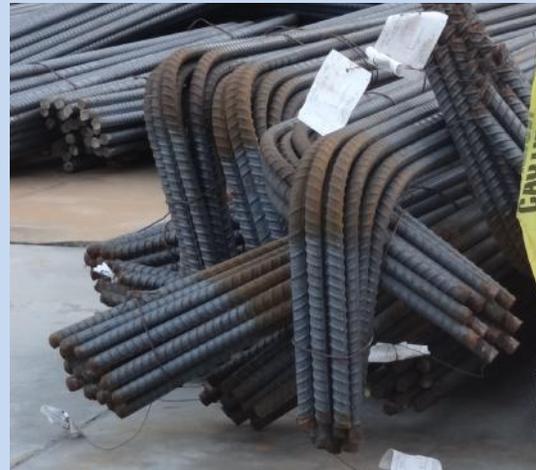
You may wonder why steel rusts when it is not in contact with another metal; there is enough physical difference in the steel that small regions will act as anodes and other regions act as cathodes. In the photo below, simply bending the reinforcing bars changed the steel properties enough that the bent regions of the bars became anodic relative to the straight sections, causing them to rust first.

When the initial anodic regions rust away, other regions are next in line. Thus if we have metal items that we want to keep from corroding, we need to protect them somehow. One way to protect them is to coat them with paint to keep the moisture and oxygen away. Another method is “*cathodic protection*,” i.e., protecting the cathode from corrosion.

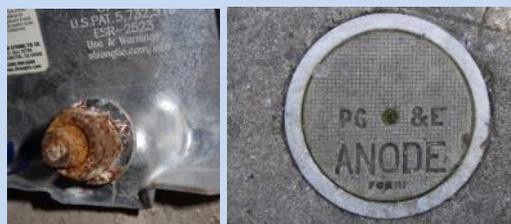
Galvanic corrosion occurs because our metal parts create a crude battery. Since the process involves very weak electrical current, the anode (metal that corrodes) does not have to be in contact with the cathode—just joined to it by a wire or other metal part. The photo at left below shows a concrete anchor with significant corrosion only three months after installation, and it was not even touching the ACQ-treated lumber; it was connected to a UFP10, which was in turn attached to the ACQ lumber. Most importantly, *the process does not stop until all of the anode material has corroded*. Sacrificial anodes must be replaced periodically, or protection is lost for the boat hull, oil pipeline, or structural framing connector. The photo below right shows a sidewalk access cover for Pacific Gas & Electric Company to replace an anode that is protecting an underground pipeline from corroding; if they do not replace the anodes regularly, the pipelines would corrode and eventually leak.

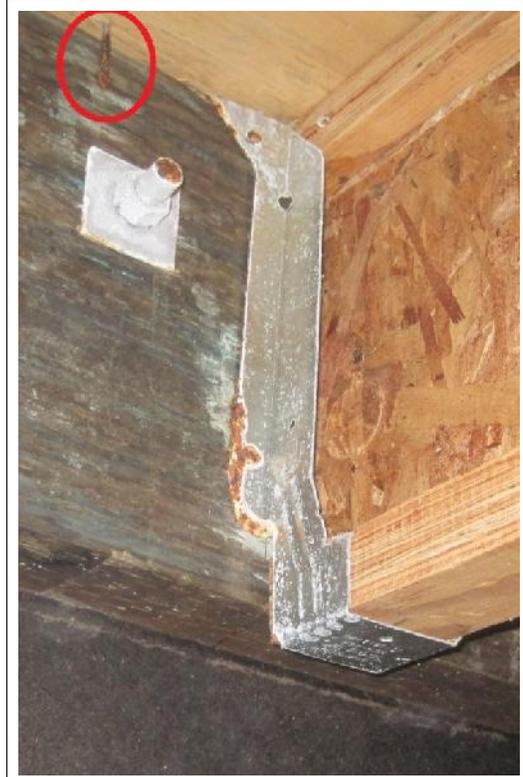
Figure 8-49 This installation was four years old when photographed. Note the red circle at the top of the picture, which shows a rusted nail that is just barely touching the PT ledger.

Also note that the PT ledger is separated from a concrete foundation wall with tarpaper, which reduces the moisture that would wick into the wood from the concrete.

The manufacturer of the joist hanger shown recommends replacing hardware that has any “red rust” on it. *Hint: Replace with stainless steel if you do not want to repeat this process every four years.* Photo by John Fryer, GGASHI

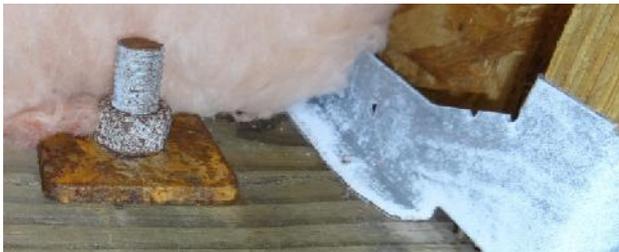
Figure 8-50 Six-year old installation in a mechanically vented crawlspace, where air circulation was provided by a fan to provide reliable ventilation. It would take a fairly long time—maybe decades—for this bolt to corrode to the point it lost significant strength. Nails are a different matter; see below.

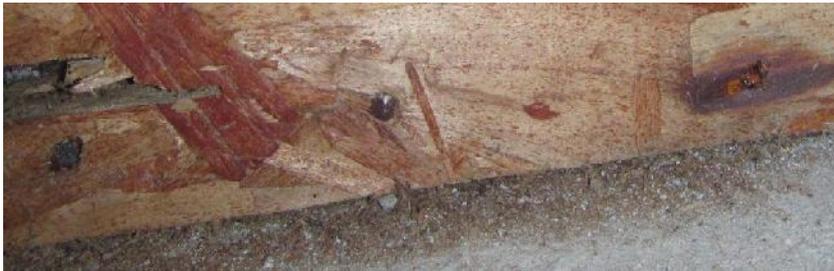
Figure 8-51 Rusty edge nailing of a shear panel, approximately five years after construction. Contractors have reported almost total corrosion of nails in just a few years. Photo by Skip Walker, Silicon Valley ASHI/CREIA

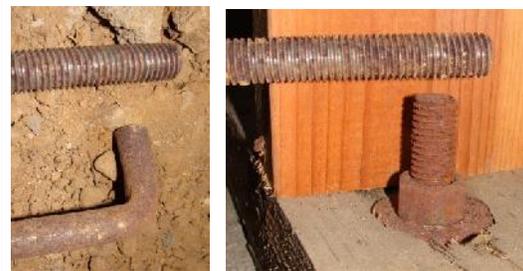
Figure 8-52 Accidental experiment—the builder left a couple of foundation anchors lying on the dirt under a house (photo above left). Photo above right compares one of them to an anchor installed in PT lumber nearby. The anchor that had been left on the bare ground still has shiny portions, whereas rust completely covers the anchor installed in the PT lumber.

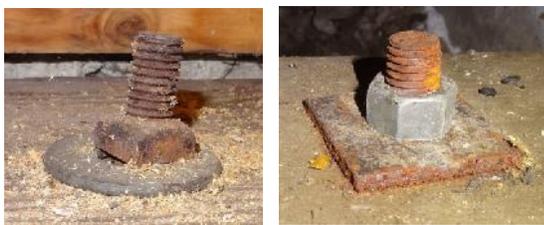
Figure 8-53 Anchor bolt on left is from original 90-year-old construction. Anchor on right was installed in PT lumber for an eight-year old remodel in the same crawlspace. The anchor in the PT material looks worse than the older one. Photos: Justin Brodowski

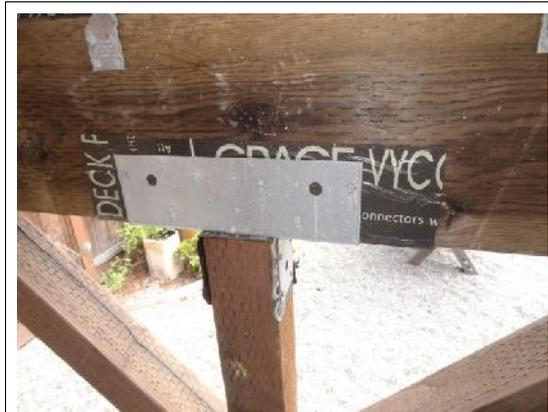
Figure 8-54 PT lumber separated from a sheet metal connector with a self-adhered membrane. The nails still penetrate the PT lumber. This method may delay corrosion in the connector, but the membrane does not offer any improved protection for the nails.

The membrane shown in Figure 8-54 is marketed specifically for decks, which are one of the main uses of PT lumber. At least you can usually access connections under decks to monitor the condition of the steel now and then.

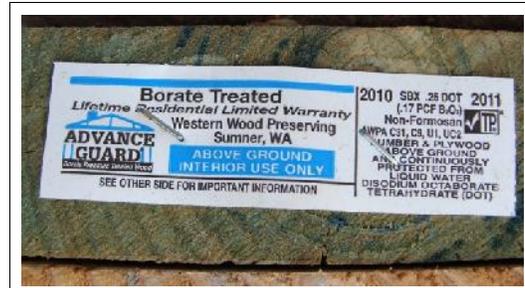
Figure 8-55 Borate-treated lumber does not corrode fasteners; it is also not toxic to mammals. Borate-treated lumber cannot be exposed to liquid water, but is appropriate for most retrofit applications. It is also usually less expensive than wood treated with toxic chemicals. California Cascade Industries (phone 800-339-6480) supplies borate-treated lumber throughout the state. A few lumber yards in the SF Bay Area [Osborne Lumber (in Newark), Sierra Point Lumber (Brisbane) and Golden State Lumber (several locations)] carry borate PT lumber as a regular stock item in limited sizes and lengths. Special-ordering from other yards is very worthwhile—but see the warning in the sidebar, next page.
